29. THE ACCIDENT

30. DAMAGE TO THE AIRCRAFT

31. THE INVESTIGATION

32. THE ANALYSIS

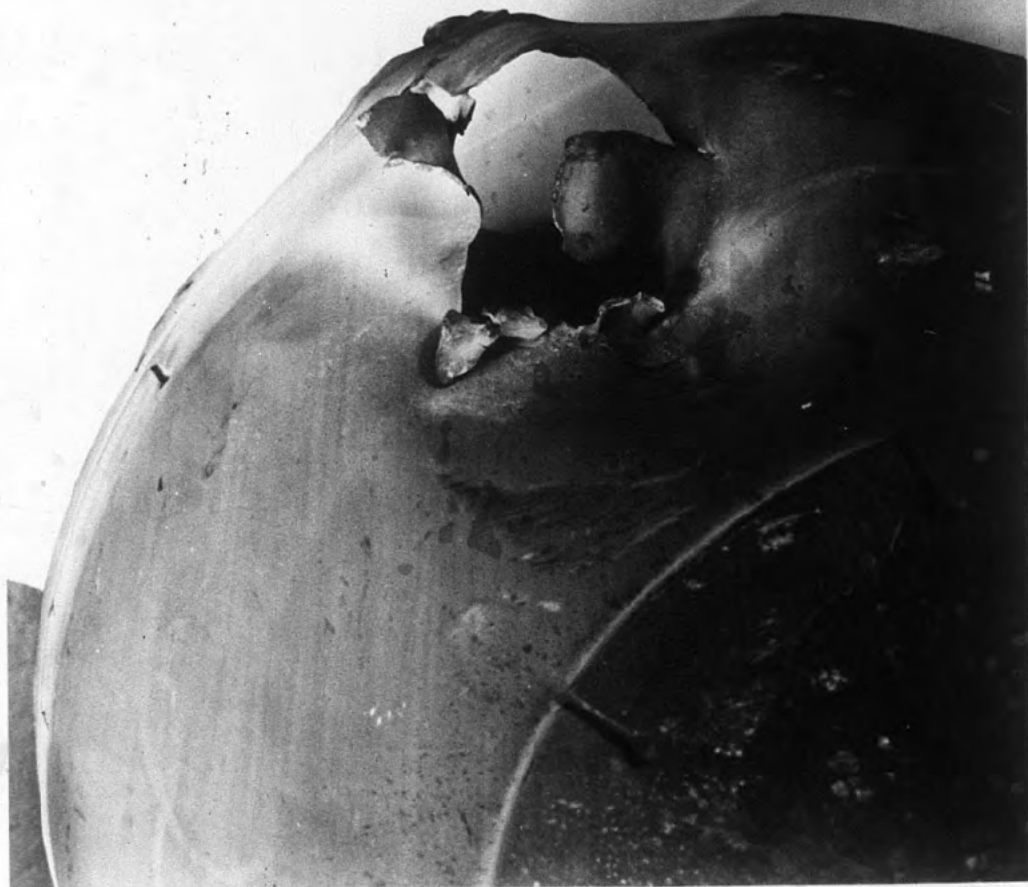
10-2

The number three (3) combustion chamber was submitted to NIS, North Island O & R Laboratory for an analysis to determine if conclusive evidence could be obtained that a 20MM round did penetrate the chamber. The laboratory analysis is forwarded as enclosure 16. The laboratory findings were; that an object partially composed of a copper bearing alloy caused the penetration of the number three (3) combustion chamber.

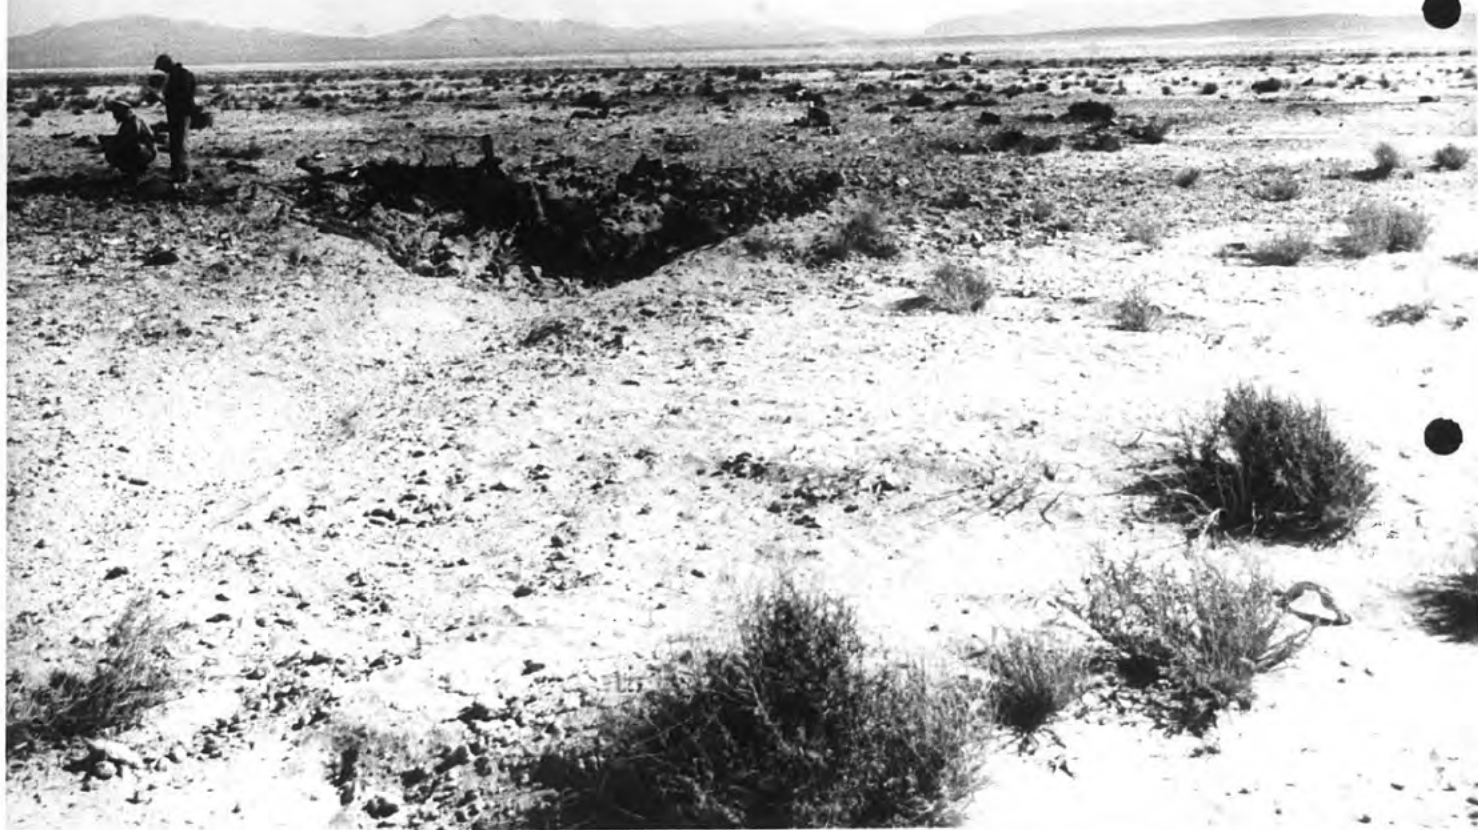
ENCLOSURE (3)

The aircraft struck the desert at an estimated angle of 20-25° and a speed of about 200 knots. The aircraft disintegrated upon impact and exploded as evidenced by enclosures 11 through 18. All instruments were demolished by fire and impact and were useless for any determination of attitude or condition. The largest piece of the wreckage was a portion of the tail assembly as shown in enclosure 15. Debris of the wreckage was scattered over one-third of a mile from initial impact area. Number three (3) combustion chamber, along with four (4) others, were recovered comparatively intact. It was evident that the skin of the fuselage, in the area of the turbine had been weakened and, by the time of the impact with the ground, perhaps as much as 30% of the structure could have been destroyed. The latter partly accounting for the complete separation of the after section (engine jet) on impact and traveling the greatest distance from the initial impact area.
